# **Kolomoki Mitigation Bank, Spring Creek Mitigation Area**

## **Third Year Stream Monitoring Report**

**January 2012 through December 2012**

**USACE File Number 200410120**

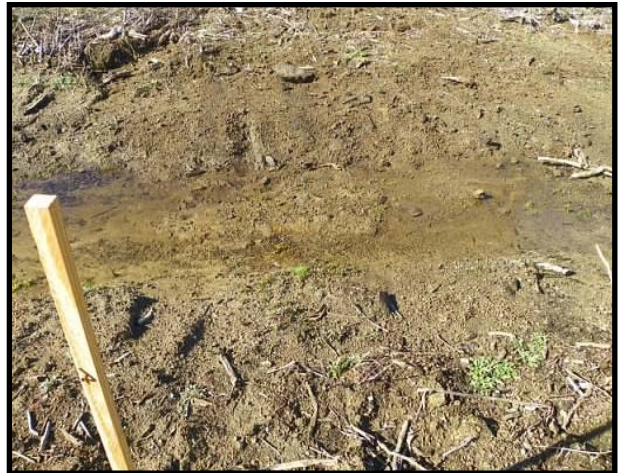
Photo 4: Survey stake placed at point of bedrock within streambed (January 30, 2012).

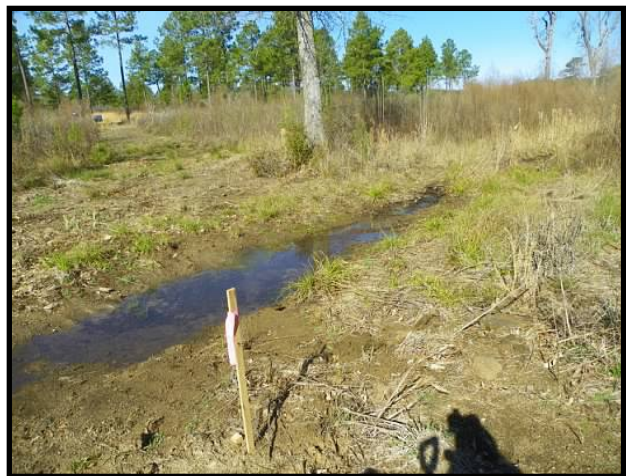
Photo 5: Survey stakes placed at head of T1B identifying point of slightly higher elevation and where additional work will be done (January 30, 2012).

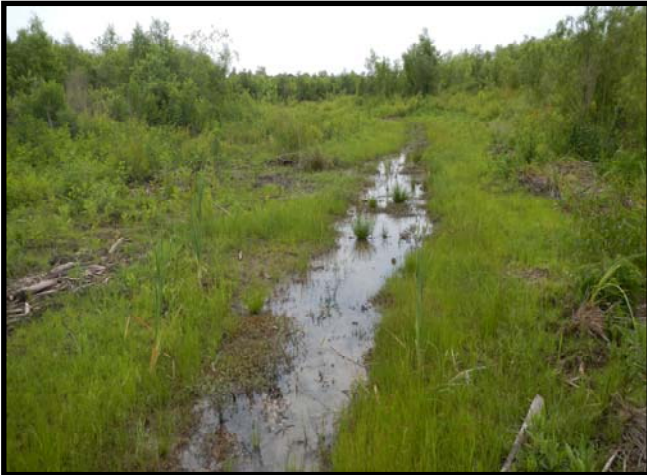
Photo 15: Lower section of T1-B with pointbar and herbaceous vegetation, but with less rocky substrate (May 2012).

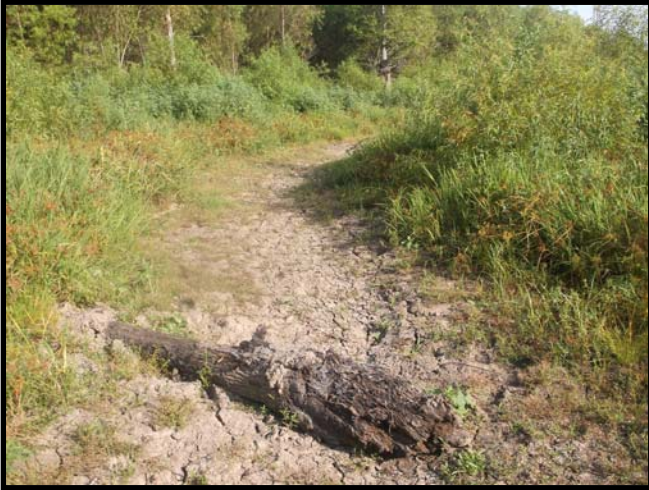
Photo 40: Standing within T1-Lower, overlooking dry channel and woody debris.

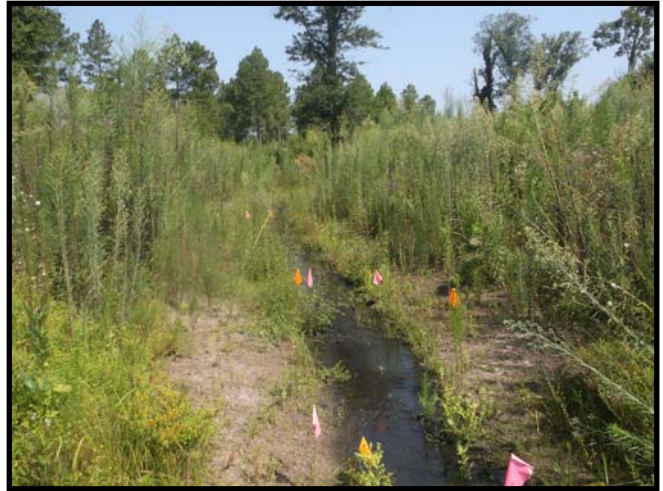
Photo 41: Standing within T1-Upper, overlooking portion of channel with flow.
